INDUSTRIAL STORM WATER INSPECTION REPORT

INSPECTION DATE: 1-19-01 REPORT DATE: 1-22-01 WEATHER CONDITION: Clear

Macleod Metals
NAME OF OWNER, AGENCY OR PARTY RESPONSIBLE FOR DISCHARGE

FACILITY NAME (IF DIFFERENT FROM OWNER)
9340 Rango Ave
FACILITY STREET ADDRESS

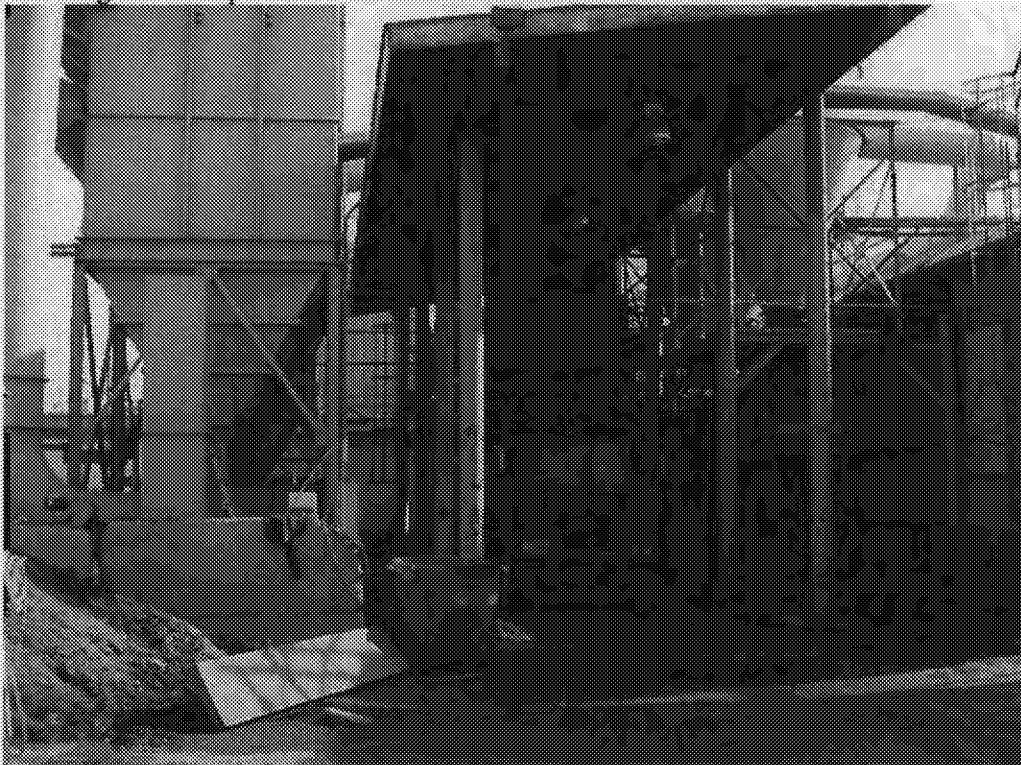
Macleod Metals 1-19-01. This picture was taken of the wire insulation processing area. Wire insulation is separated from metal wire and the insulation ground up. The separation and unloading of the scrap wire is done underneath the covered area.

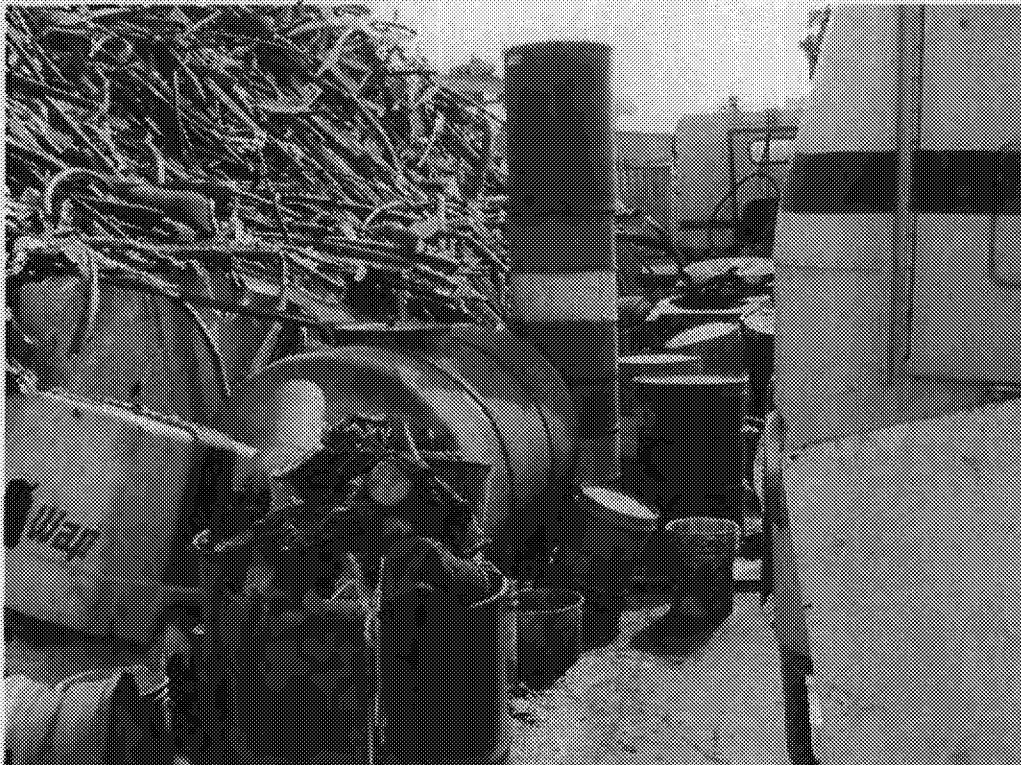
3. Is there secondary containment for liquid storage?		X			Waste Oil Storage tank needs secondary
4. Are current BMPs in the material storage areas adequate?		X

Macleod Metals WDID #419S 003226 1-19-01. Picture was taken of facility's waste oil storage. Notew the lack of secondary containment.

Issue Notice to Comply: X

For lack of secondary containment
on waste oil storage
